# Libby Asbestos Site

Libby, Montana

**Final Data Summary Report  
Operable Unit 2 - Former Screening Plant and  
Surrounding Area  
Libby Asbestos Site  
Libby, Montana**

**May 13, 2008**

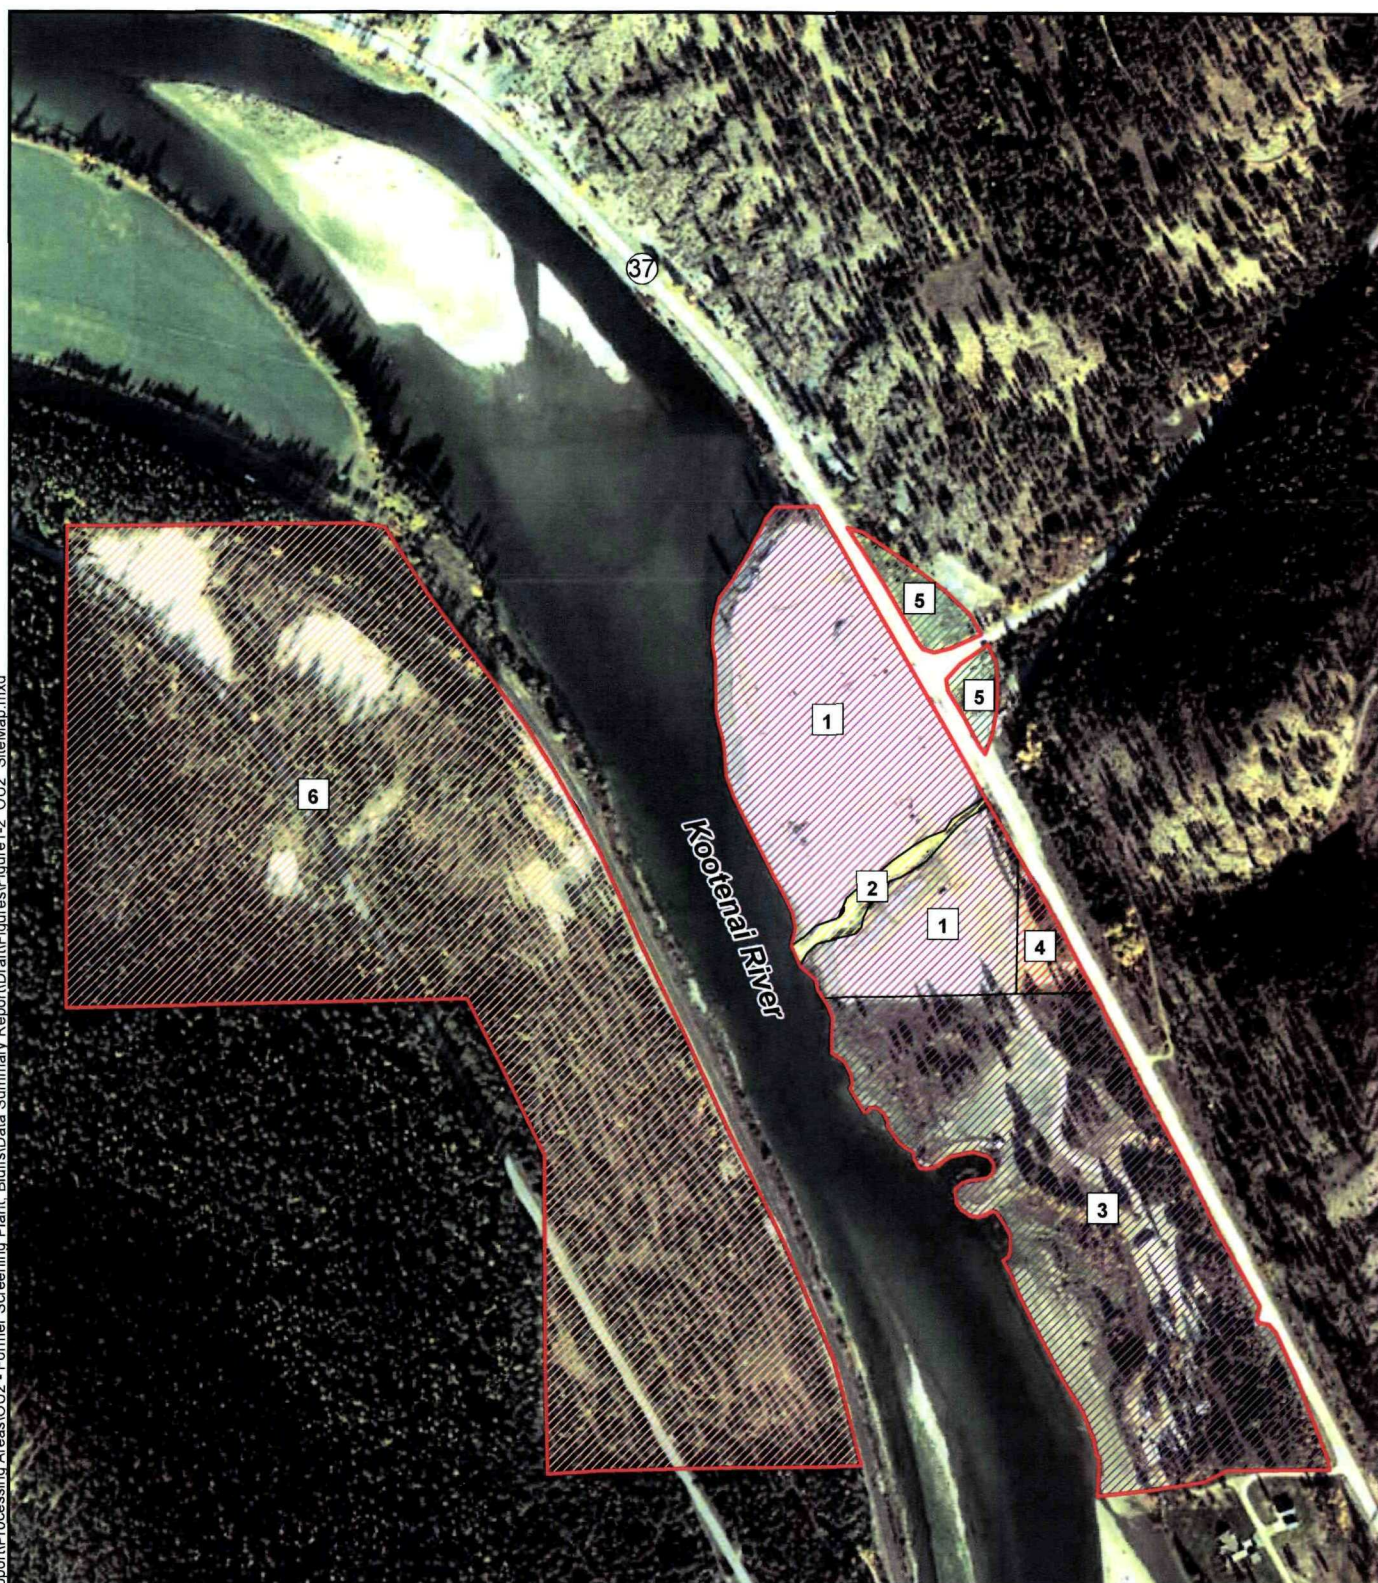
- OU 2 Boundary
- 1- Former Screening Plant
- 2 - Rainy Creek/Rainy Creek Bank
- 3 - Flyway
- 4 - Wlse Property
- 5 - Rainy Creek Road (Frontage)
- 6 - Kootenai Bluffs Subdivision

The exact geographic area of OU2 has not yet been defined, but includes areas impacted by contamination released from the former Screening Plant. These areas include the former Screening Plant, Highway 37 right-of-way adjacent to the former Screening Plant, Rainy Creek (Lower Reach), Rainy Creek Road Frontage, Flyway, Wise Property, and Kootenai Bluffs Subdivision. The Kootenai Bluffs Subdivision area is located directly across the Kootenai River from the former Screening Plant. Each of the sub areas of OU2 are depicted in Figure 1-2.
